"Blight-free NC" – Operation Blight Busting/Project Landlord

PROJECT LANDLORD//BLIGHT BUSTING 2016

DANGEROUS & UNSAFE STRUCTURE INSPECTION REPORT

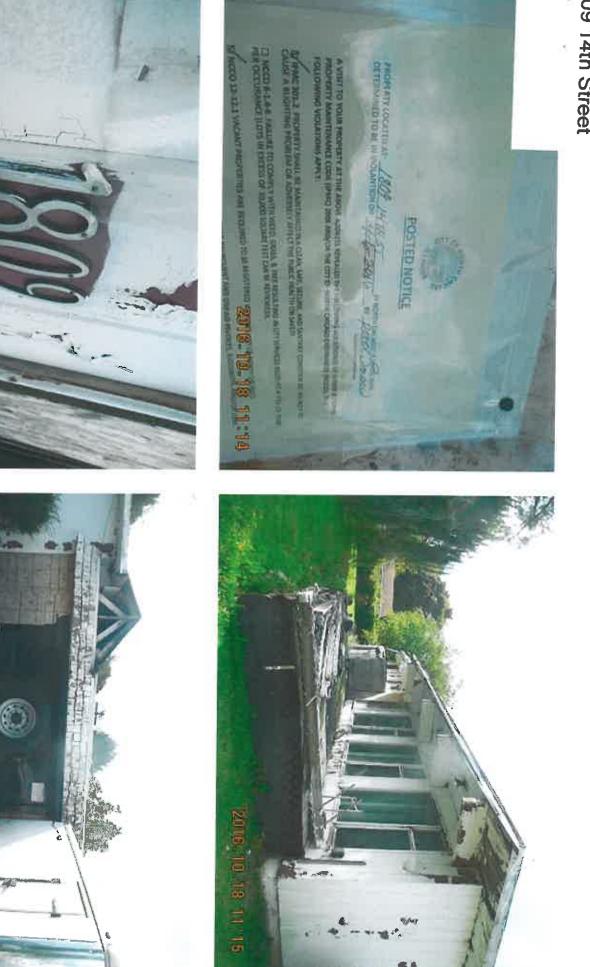
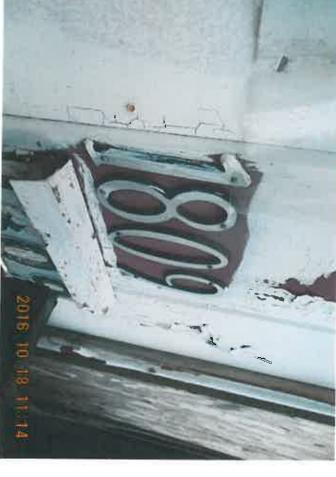
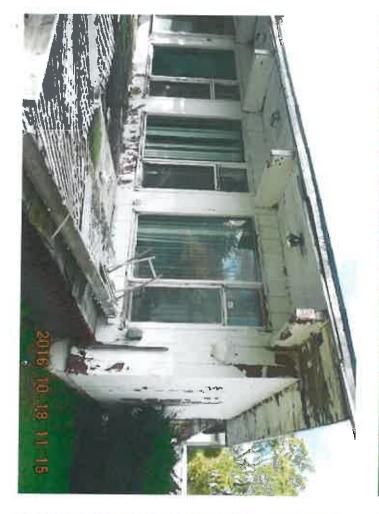
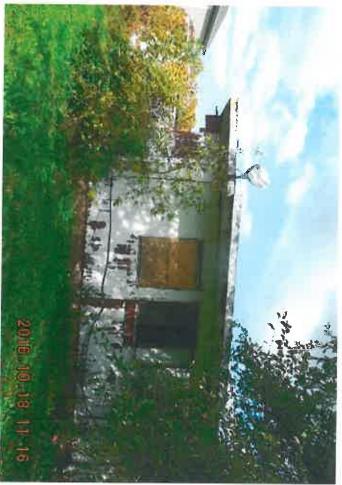
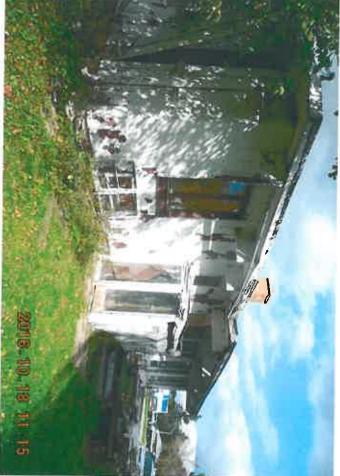
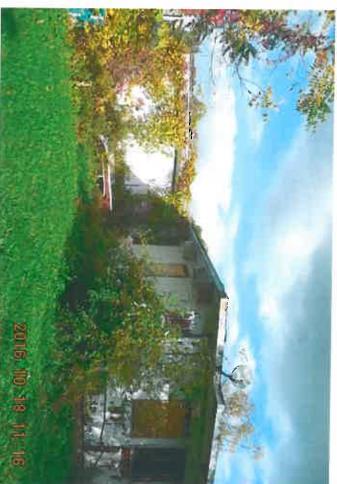
1809 14th Street

The building is wood frame and the is in a state of disrepair that the wood frame of the structure is rotted beyond repair.

The building is unsecured, open and vacant and poses an immeditate and continuing hazard.

The roof is faulty and wom to a point that it would not provide sufficant cover to the structure. There are several holes in the roof that allow the elements into the structure which can create a hazardous condition including mold growth.

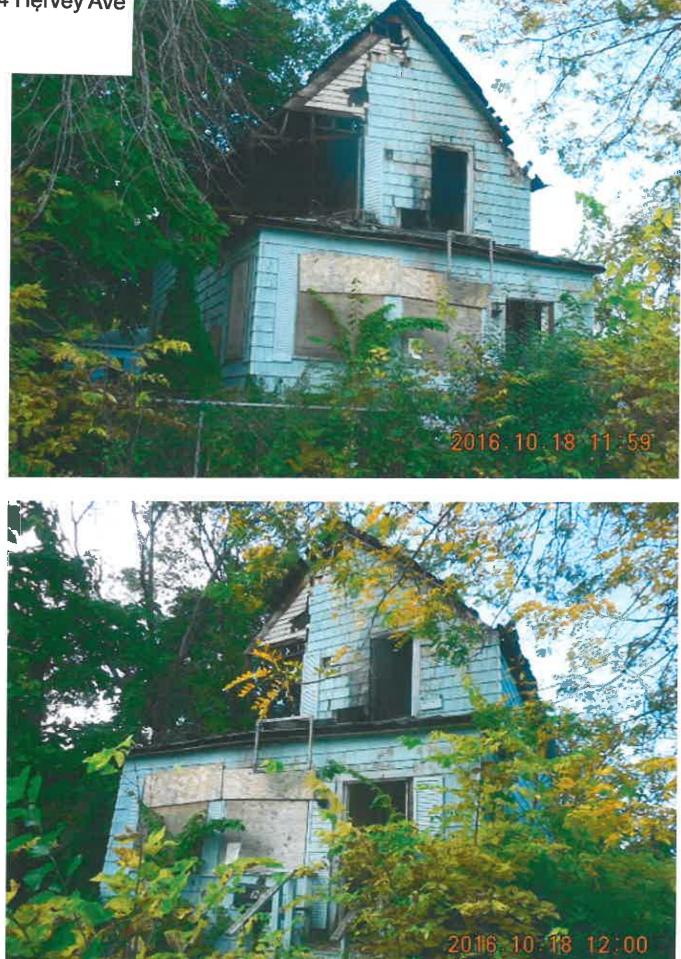
2214 Hervey Ave

This building is condemed and structurally unsafe.

There was a fire in this building and a large portion of the second floor and roof have burned away and left it open to the elements for some time.

The southwest corner of the second floor and the roof have burned away leaving the

building open to the elements and unsafe.

The roof is faulty and worn to a point that it would not provide sufficant cover to the structure. A major portion of the roof has burned away and the building has been open to the elements for some time allowing for deteration and insfestation of the interior.

A majority of the windows and doors are missing from the fire.

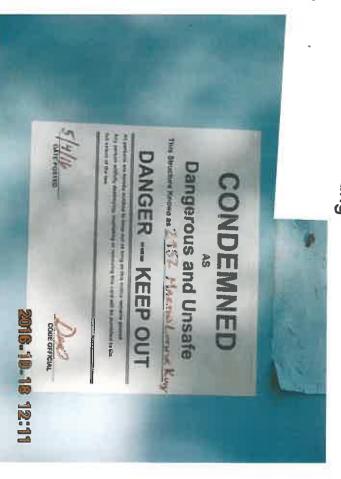
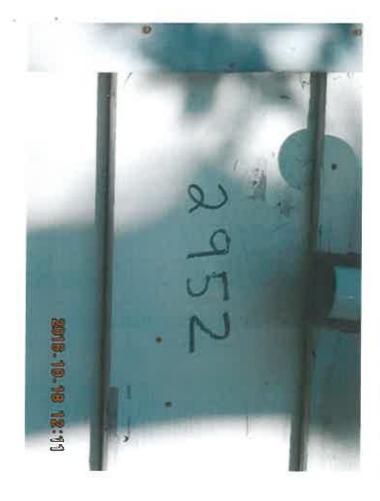
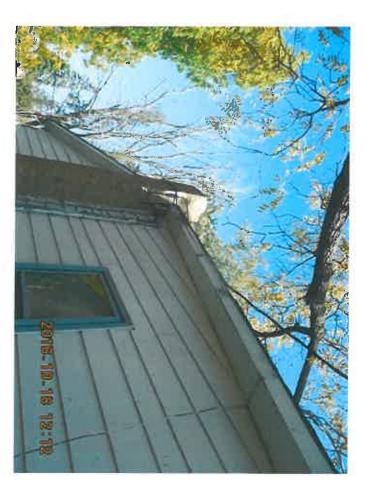
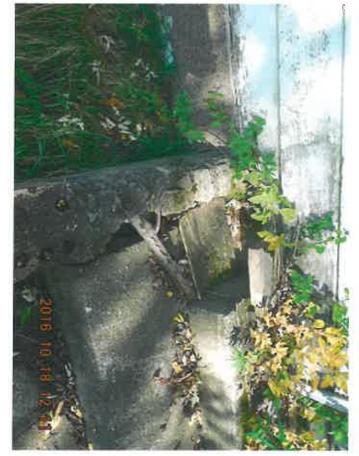
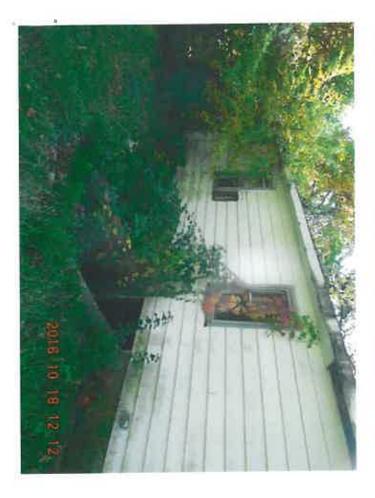
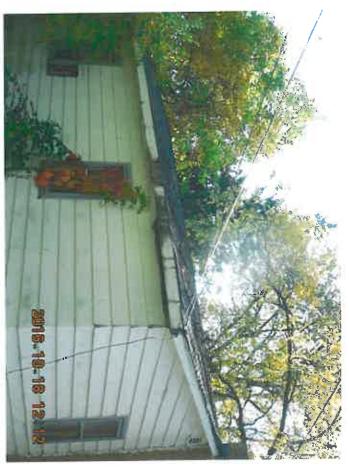
2952 Martin Luther King

Structure is unsafe. There are holes in the exterior walls which would allow for rodents or squatters to enter. The openings in the structure also allow for weather to effect the interior and can create a hazardous condition including mold growth. The building is beyond resonable repair.

The foundation is block and has several cracks and has shifted in some areas. It is unsafe and the building has been condemed due to the foundation issues.

The roof is fautly and worn to a point that it would not provide sufficant cover to the structure.

The structure is unsecure and vacant and poses an immediate and continuing hazard. The real windows are open as well as the basement door. There is also a hole in the rear exterior wall.

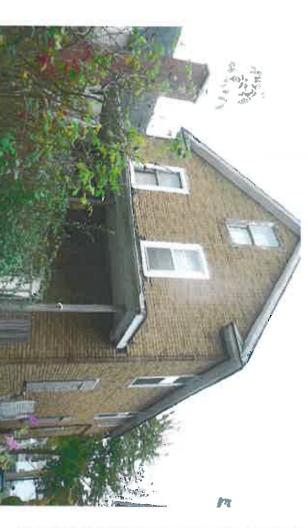
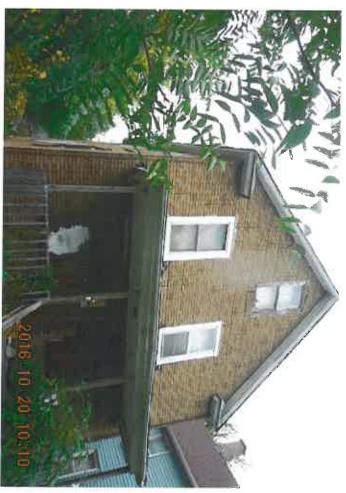
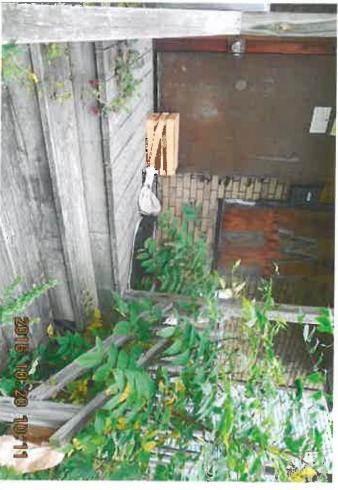
1036 Park Ave

This structure has been vacant for over ten years with no maintenance or upkeep performed. The home and grounds are filled with debris and have been left in unsanitary condition.

Areas of the siding area missing as well as some trim around windows. This has left the wooden framing exposed to the elements.

The foundation is brick and has several cracks and has shifted in some areas.

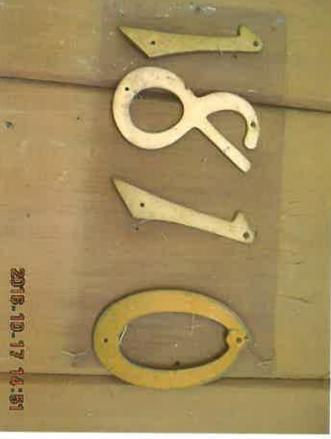
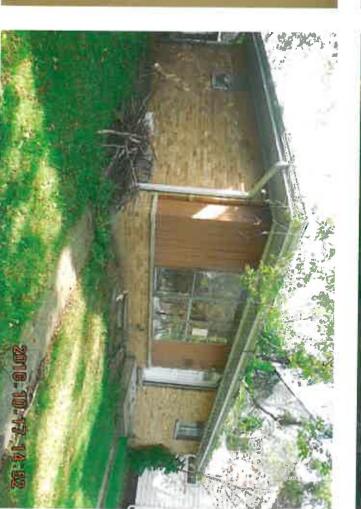
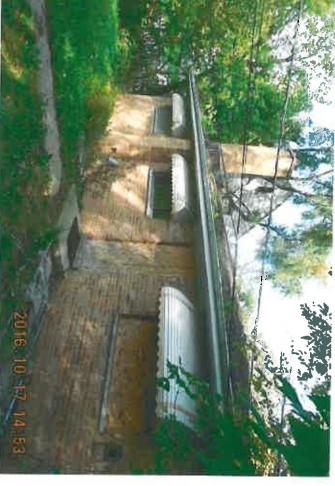
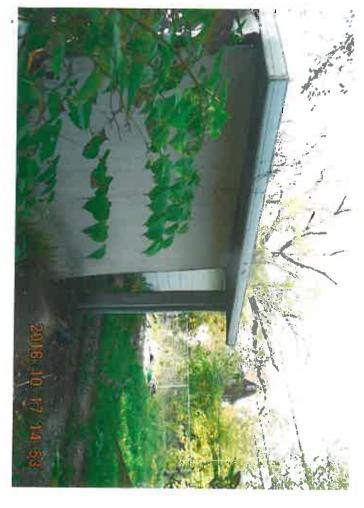
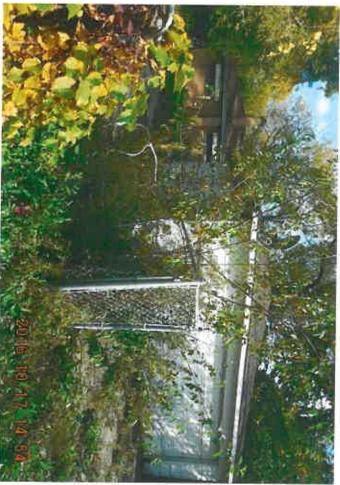
1810 Seymour Ave

The accessory structure on the property is unsafe and beyond repair.

Main structure and foundation appear sound but unable to verify from exterior.

The roof is fautly and worn to a point that it would not provide sufficant cover to the structure.

A majority of the windows and doors are secure but some have missing panes that leave the

building open to the elements and unsafe.

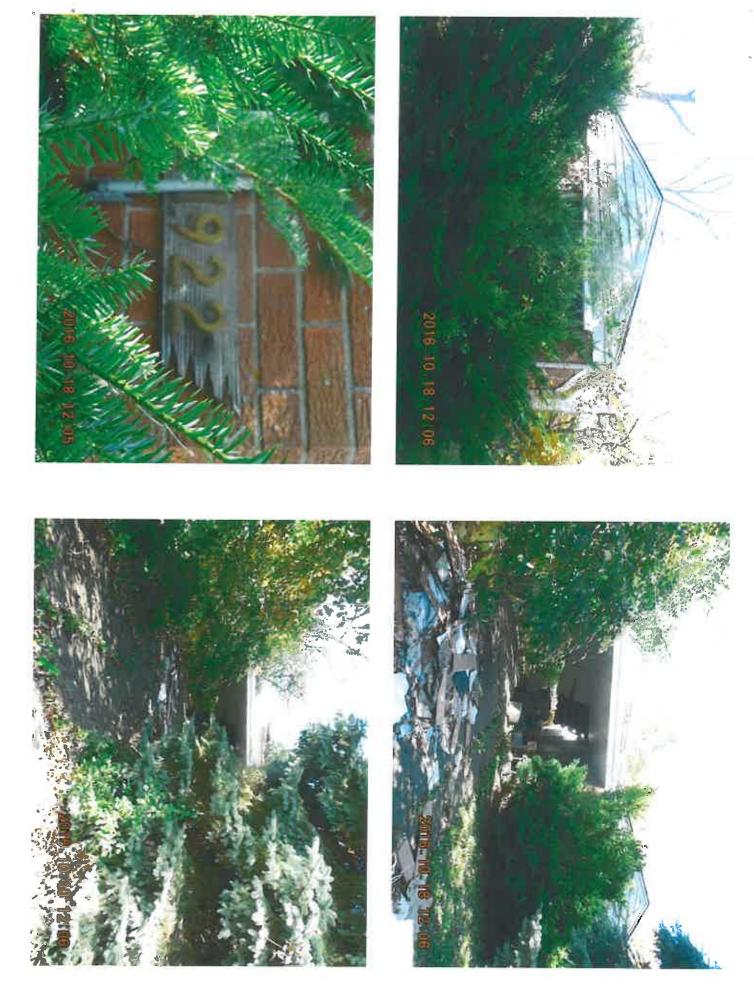
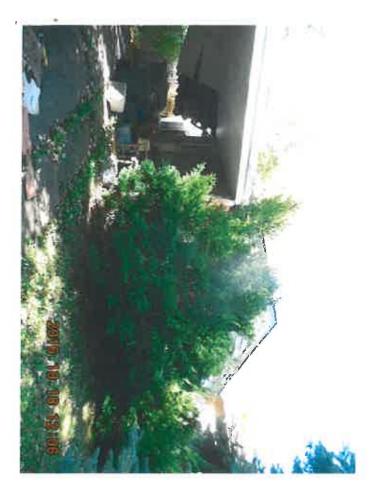
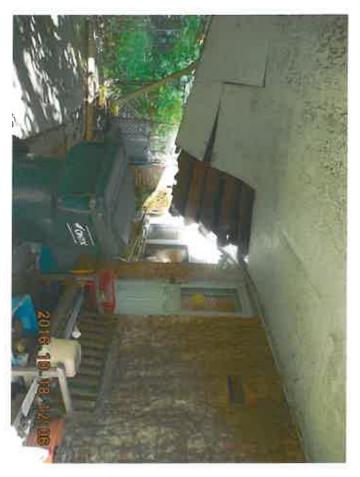
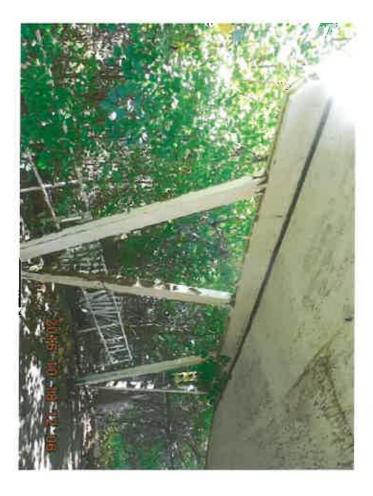
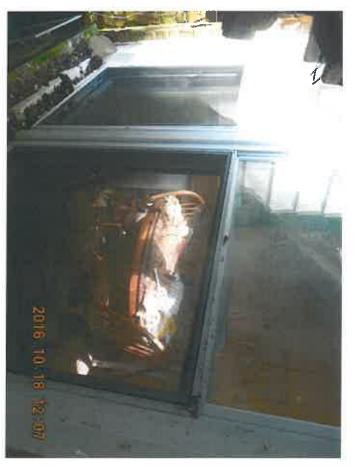
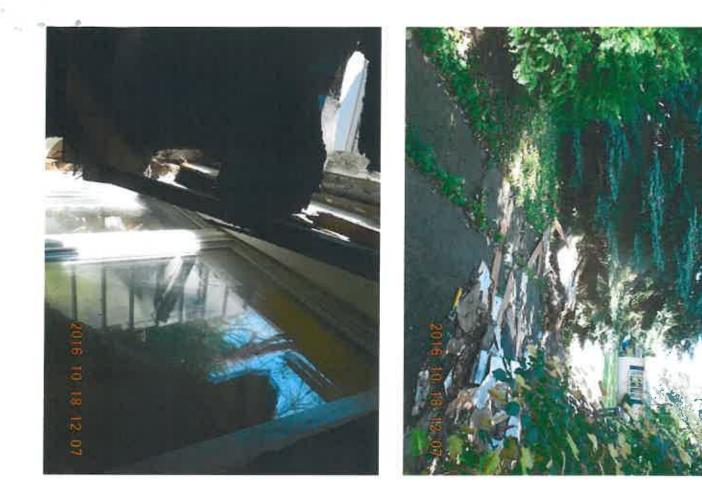
House is rundown and unmaintained for some time. Attached carport has collapsed. Kitchen ceiling has fallen in due to leak from roof. Water damage in several areas of the house.

Main structure and foundation appear sound but unable to verify from exterior.

Several small openings are present in vents throughout foundation. This could allow for rodent harborage and unsanitary conditions.

Roof shingles are very worn and roof has several leaks into house. Roof appears faulty and is allowing water to leak into structure causing unsafe and hazardous conditions
